**US Army Corps  
of Engineers**

Waterways Experiment  
Station

Technical Report EL-98-17  
December 1998

# **Evaluation of Infrasound and Strobe Lights for Redistributing Migrant Salmon Smolts in the McNary Juvenile Bypass: 1997**

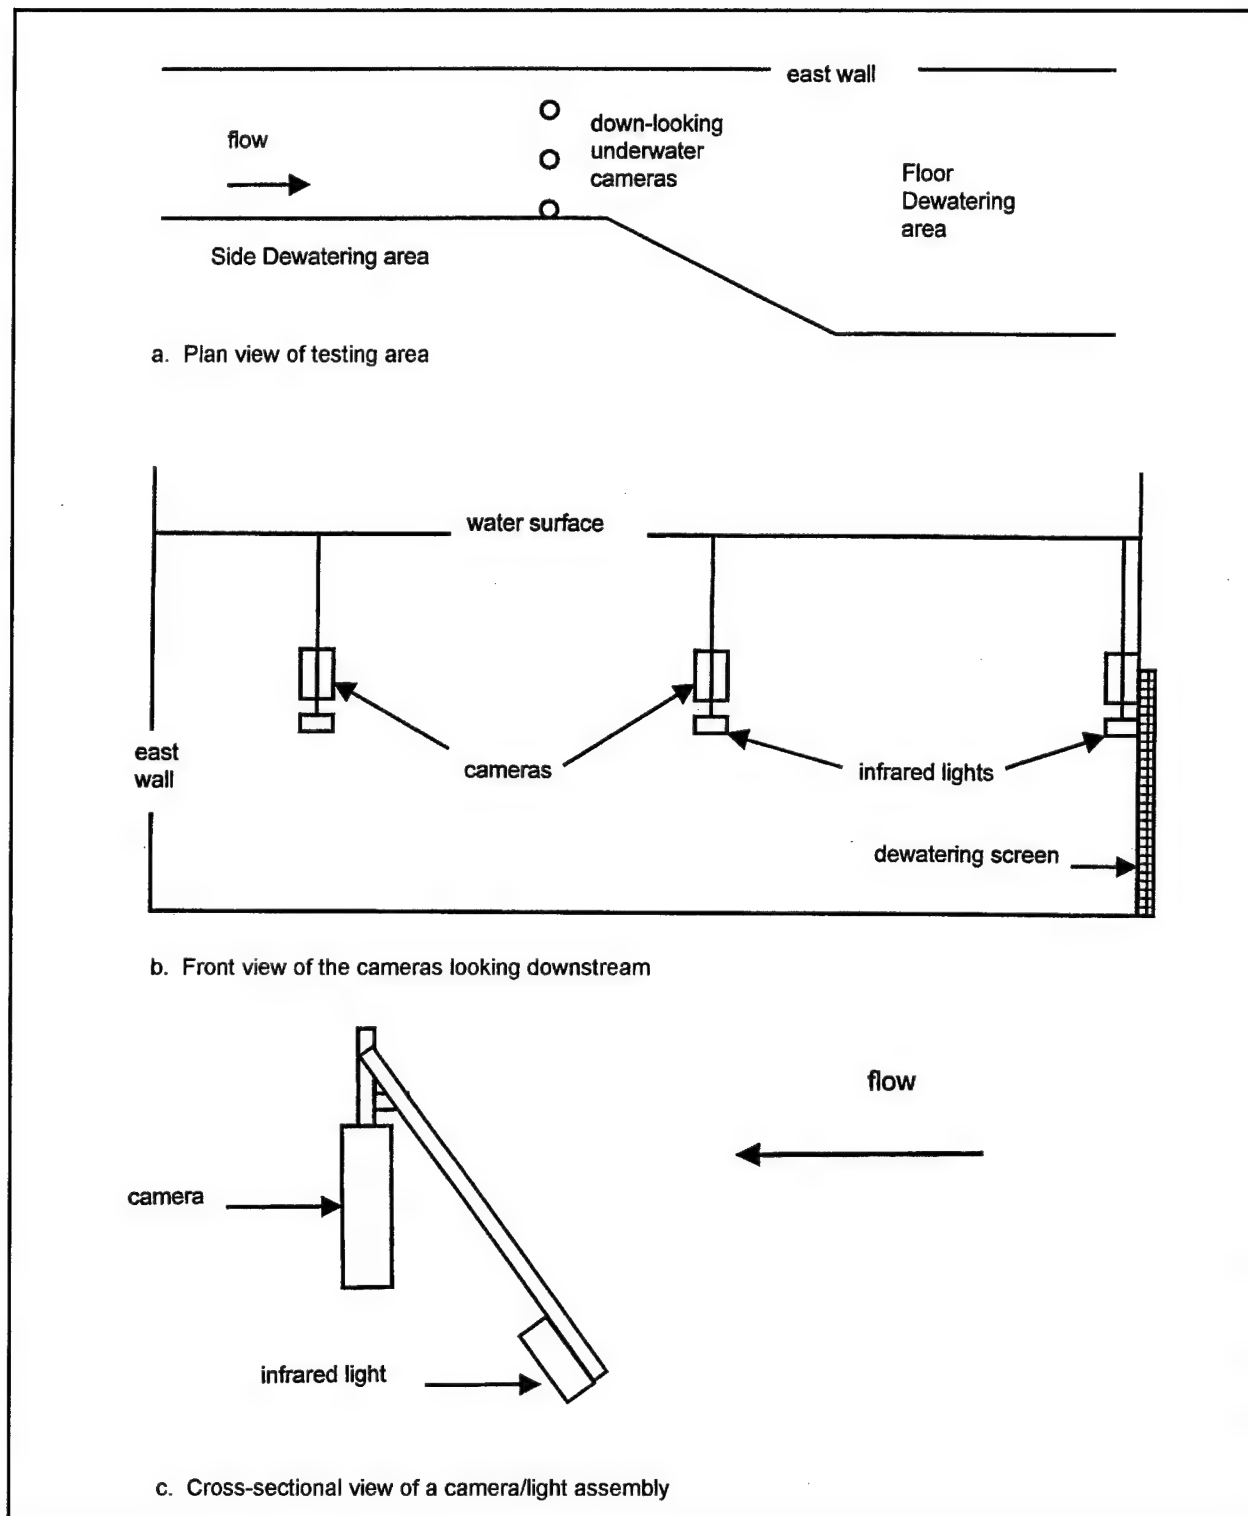
Figure 2. Underwater camera locations within the McNary juvenile bypass (not to scale)

Monitoring gear consisted of three high-resolution black and white infrared-sensitive underwater cameras spanning the width of the channel just upstream of the side dewatering platform (Figure 2). The cameras were suspended from vertical poles, placed 0.3 m below the elevation of the top of the dewatering screens, and aimed down. A single infrared light bank per camera was used to provide illumination. The cameras were spaced laterally as follows: camera 1 was adjacent to the dewatering screen (screen was visible in that camera's field of view for monitoring debris loading); camera 2 was 0.7 m from camera 1; and camera 3 was 0.8 m from camera 2 and nearest to the east wall of the channel.

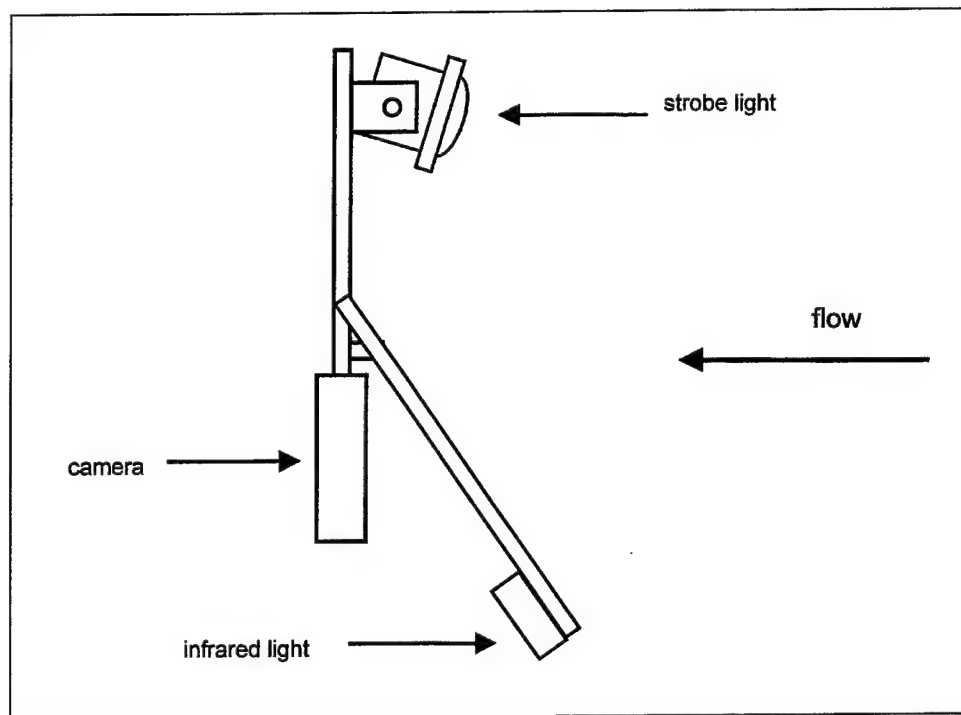
Figure 3. Cross-sectional view of center camera and light assembly showing position of strobe light for April 1997 testing in the McNary juvenile bypass channel. Strobe light orientation of 45 deg toward the screened wall is not shown. Drawing is not to scale

Testing configuration consisted of a single Flash Technology, Inc., AGL Series 901 strobe head mounted to the middle camera pole 0.5 m above the camera and angled approximately 45 deg toward the screen wall and 20 deg down (Figure 3). We used a flash rate of 100 flashes per minute (fpm) at low intensity (400 watts). AGL Series strobe heads measure 23.5 cm in diameter with a body depth of 17.1 cm.

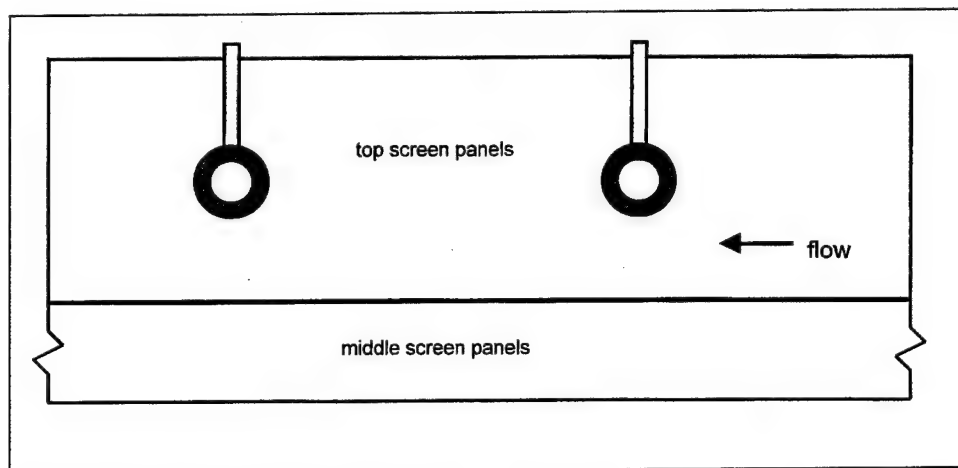
Figure 4. Front view of strobe light locations for April 1997 testing in the McNary juvenile bypass channel. Strobe lights were placed along the face of screens at a distance of 4.3 and 7.3 m upchannel from monitoring cameras. Drawing is not to scale

The monitoring configuration in May differed from that of April with the addition of an overhead camera hung from the crane hook and aimed down to capture avoidance behavior of surface-oriented smolts. The May testing configuration differed from that of April in that instead of using a single strobe head near the monitoring cameras, we used two strobe heads suspended from aluminum poles located along the screened wall at distances of 7.3 and 4.3 m from the monitoring cameras. The heads were placed at the elevation of the center of the top side screens, aimed approximately 20 deg off the screens and with the flow (Figure 4). We used a flash rate of 200 fpm at low intensity.

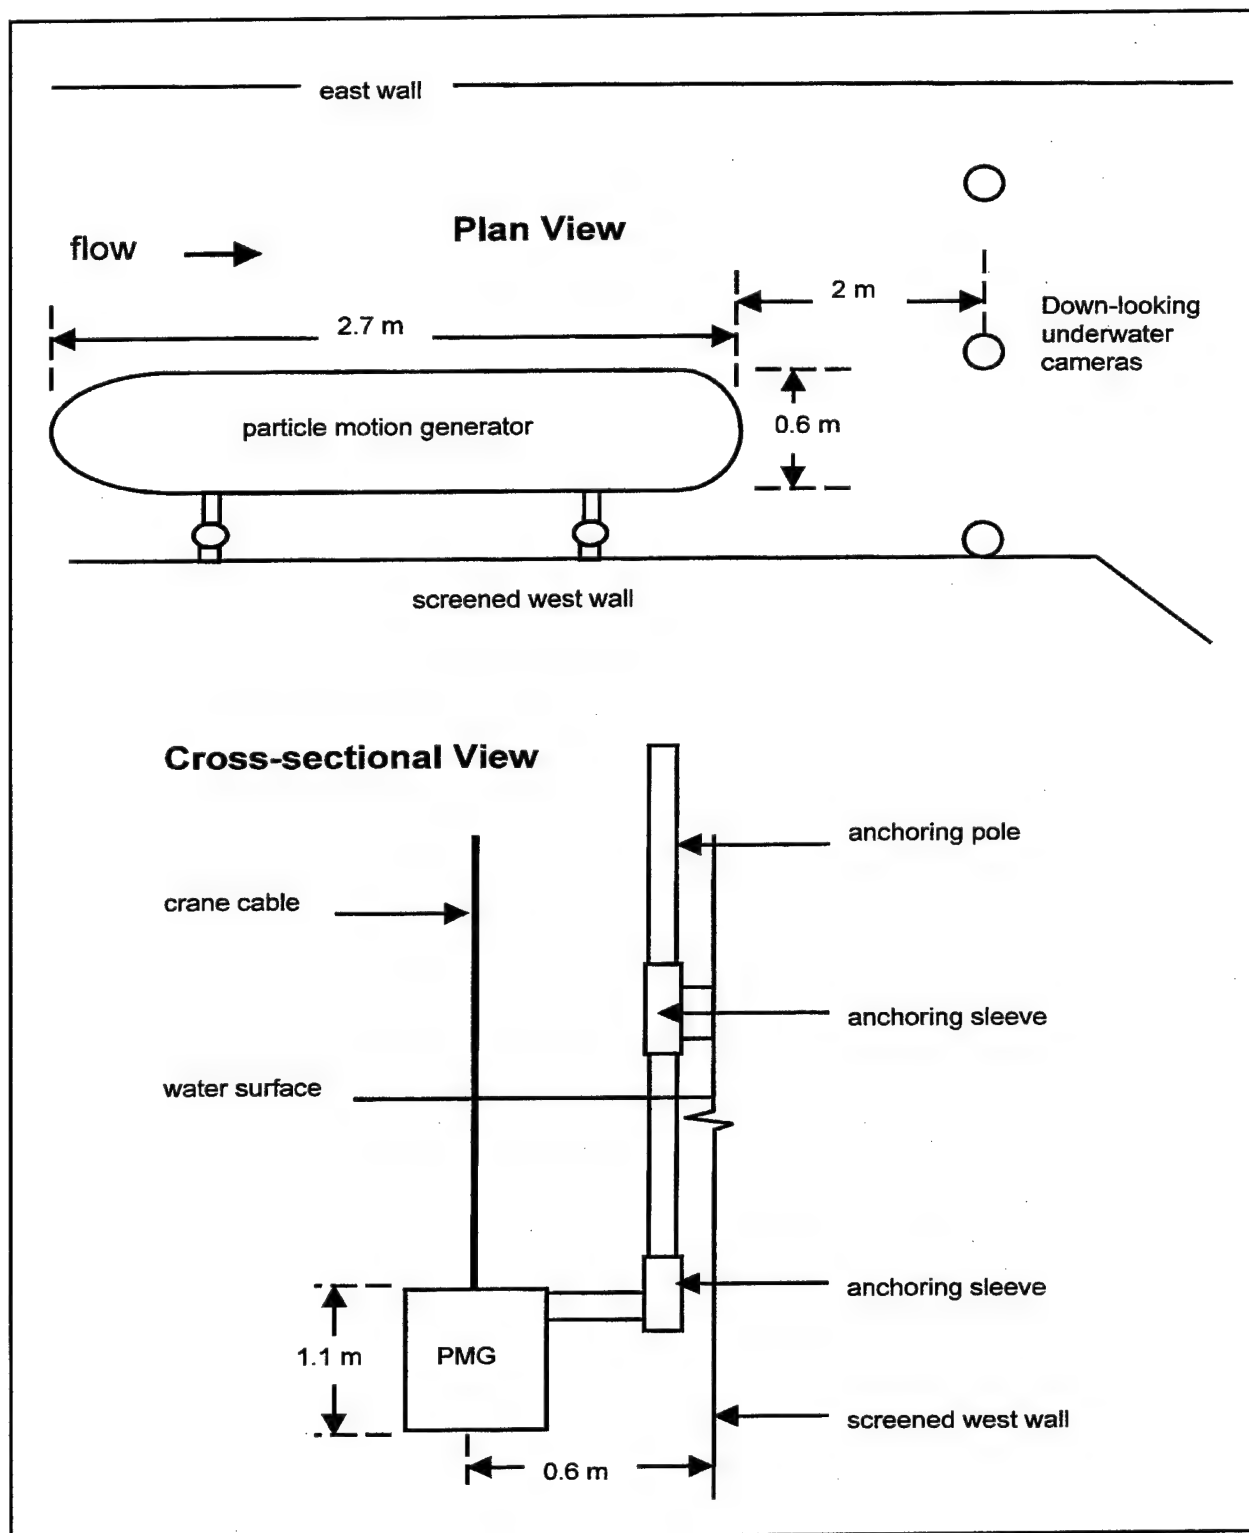
Figure 5. Plan and cross-sectional views of Alden Research Laboratory's particle motion generator (PMG) for April 1997 testing in the McNary juvenile bypass channel. Drawing is not to scale

Monitoring design for springtime infrasound testing was the same as in April strobe light tests. Deployment of the particle motion generator (PMG) consisted of suspending it from the overhead crane and stabilizing it with a pole and sleeve anchoring configuration (Figure 5). The center of the PMG was located 0.6 m from the screen wall, 2 m from the camera monitoring frame, and at the elevation of the middle of the top side screens.

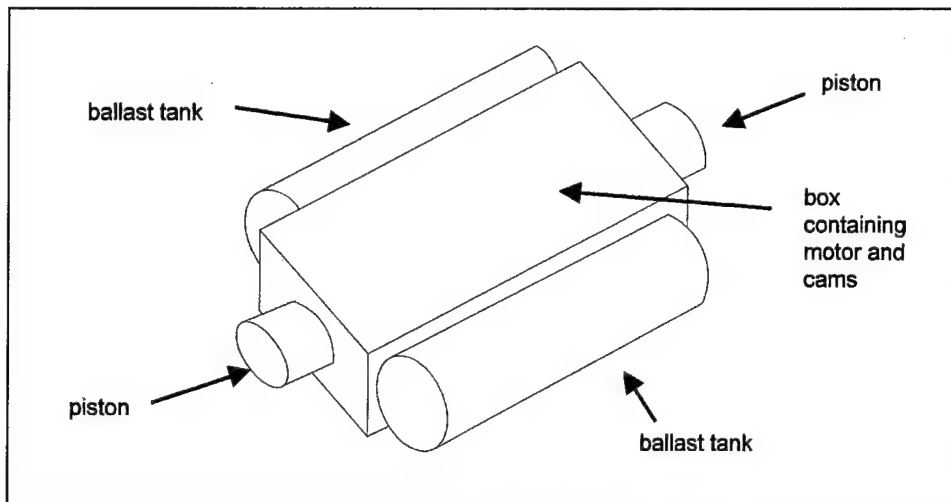
Figure 6. Three-dimensional view of Argotec's reciprocating piston-driven infrasound device

The device tested in the summer was a 1.2-m-long, 0.8-m-high, 1.1-m-wide reciprocating piston-driven PMG manufactured by Argotec, Inc. (Figure 6). We used an overhead crane to suspend the infrasound device and several ropes to stabilize it laterally. The device was placed 5 m upchannel from the furthest downstream monitoring camera, offset toward the screened wall until the crane cable contacted the screen cleaning trough, and lowered 1.2 m below the water

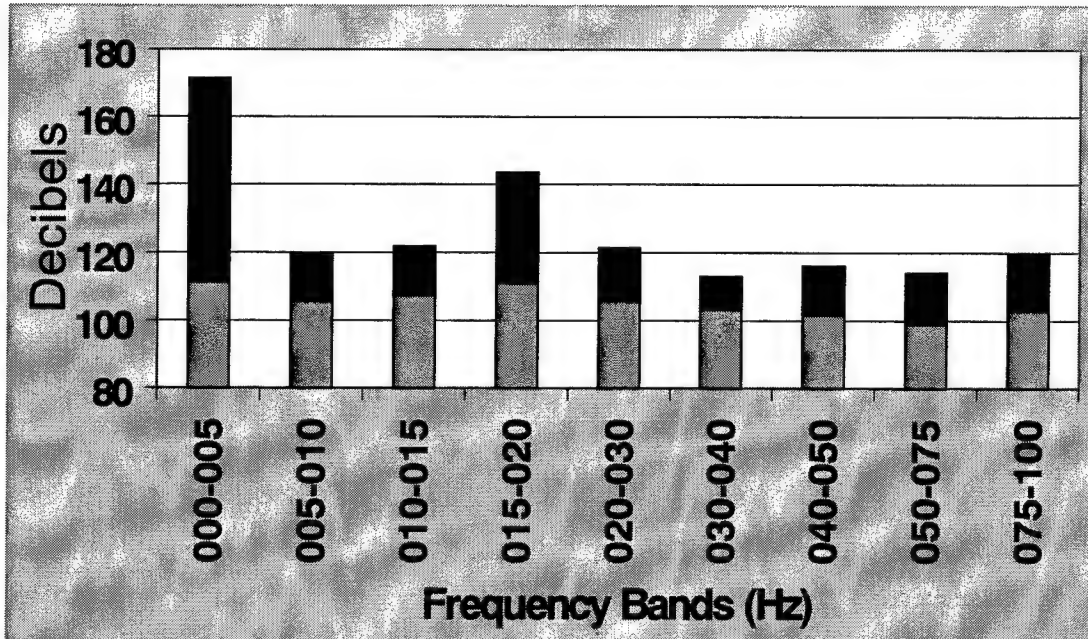
Figure 7. Mean and maximum sound pressure levels recorded from a stationary smolt transport barge below McNary Dam at 0.6-m depth. Decibels are referenced to 1  $\mu$ Pa at 1 m

Selected results of low-frequency sound surveys conducted in a smolt transportation barge are shown in Figure 7. Within the transport barge, the greatest mean and maximum sound pressure levels observed were in the frequency bands less than 5 Hz and between 15 and 20 Hz. Mean sound pressure levels at these frequencies were 111 dB referenced to 1  $\mu$ Pa at 1 m, with the maximum sound pressure reading of over 170 dB referenced to 1  $\mu$ Pa at 1 m for frequencies less than 5 Hz. Maximum sound pressure levels represent a thousand-fold increase over the mean background levels. Maximum sound pressure levels were generally slightly higher closer to the water surface compared with the measurements taken at depth.

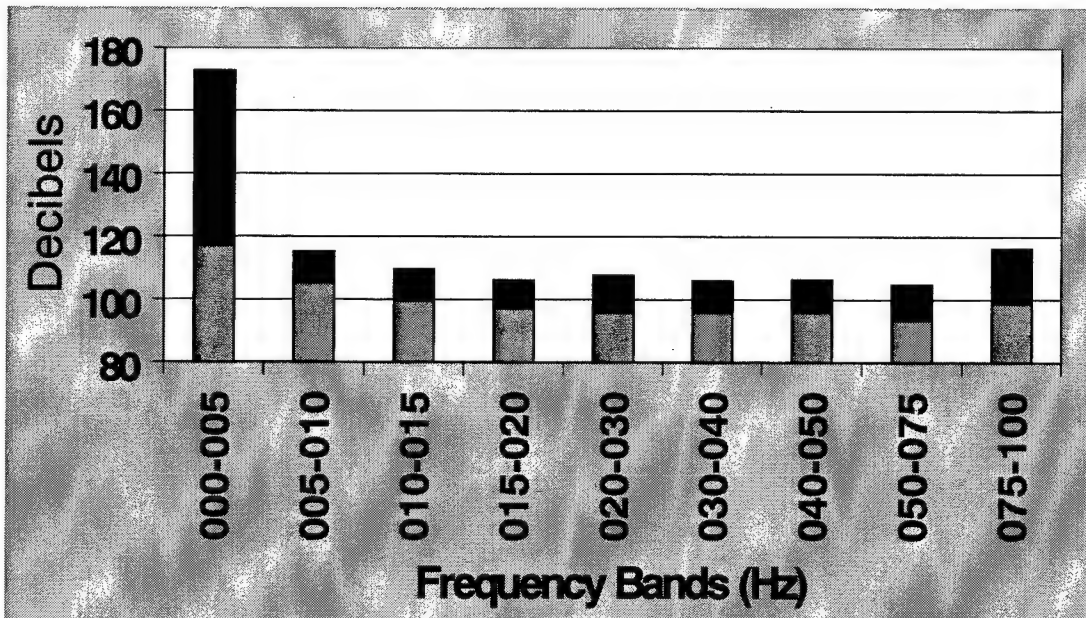
Figure 8. Mean and maximum sound pressure levels recorded from McNary fish separator. Decibels are referenced to 1  $\mu$ Pa at 1 m

Selected results of the low-frequency sound survey conducted in the McNary wet separator are shown in Figure 8. Highest mean and maximum sound pressure levels were found within the frequency bands below 5 Hz, with the maximum sound pressure reading (172 dB referenced to 1  $\mu$ Pa at 1 m) much greater than sound pressure levels for all other frequencies. This maximum sound pressure level represents a five-hundred-fold increase over the mean background levels. As with the transport barge surveys, results among all locations surveyed within the wet separator showed little variability for patterns of both sound pressure levels and frequency domain.

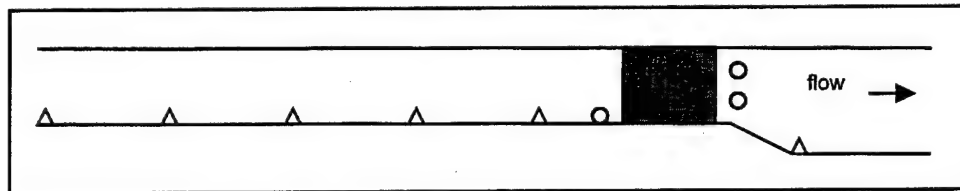
Figure 9. Plan view of a section of the McNary juvenile bypass channel showing radio-telemetry antennae locations. Antennae are indicated as triangles for general monitoring and rate of travel, or circles for specific monitoring near the test devices (shaded area). General monitoring antennae upchannel from the test devices were spaced 27 m apart. Drawing not to scale.

The fish were obtained from the fish collection facility at McNary and released into the bypass channel at turbine unit 7A about 183 m upchannel from the location of device deployment. Fifteen fish were released during a control period, and 15 fish were released during on treatments of both strobe lights and infrasound. Two groups of underwater dipole antennae were deployed in the channel (Figure 9). The first group comprised six antennae spaced 27.4 m apart extending 121.9 m above and 15.2 m below the behavioral device testing location. These antennae were designed to determine rate of fish movement down the channel. The second group consisted of one antenna positioned immediately upstream of the test devices and two additional antennae downstream on opposite sides of the collection channel. The upstream antenna was designed to detect delays in the vicinity of the test devices while the other two were intended to determine travel location.
